BRITISH ART STUDIES

Innovation in English Gothic Architecture: Risks, Impediments, and Opportunities

Article by **Roger Stalley** WORD COUNT:6,864

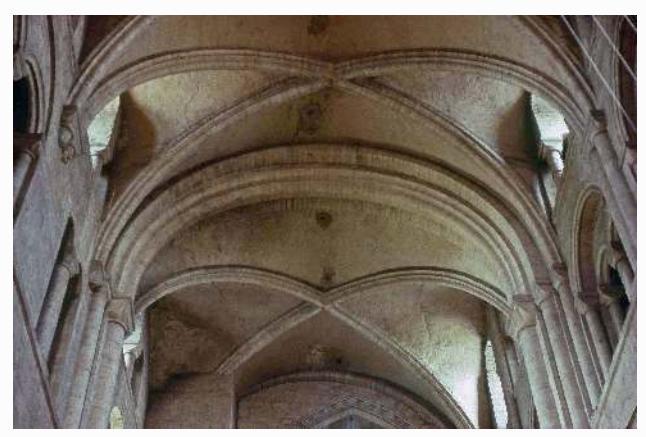
Figure 1

Durham Cathedral, vault over the north transept. Digital image courtesy of Roger Stalley.

To illustrate what was at stake it is worth noting a few creative episodes where master masons, presumably with the support of their patrons, were prepared to take bold and imaginative decisions. The first concerns the cathedral of Durham, where the ribbed vaults are well known for their precocious designs and for the way in which those designs were modified as work progressed. The vault over the north transept, built shortly after 1100, is especially interesting, in that it involved the construction of a heavy stone vault over a clerestory furnished with a continuous passageway (fig. 1).⁶ In other words, the upper levels of this part of the building were not completely solid as they were in the earlier choir. In the choir it was presumably thought that solid walls without passages were essential for the support of a stone vault. The north transept solution was thus a structural experiment, though whether anyone at the time regarded it in this way we shall never know. The experiment worked and the formula employed—the combination of a hollow clerestory with a ribbed vault—was repeated countless times in English architecture. Ironically it was the earlier vault over the choir that gave rise to structural problems: by 1235 this was full of fissures and cracks (*plenae fissuris et rimis*) and it was subsequently dismantled and rebuilt.⁷

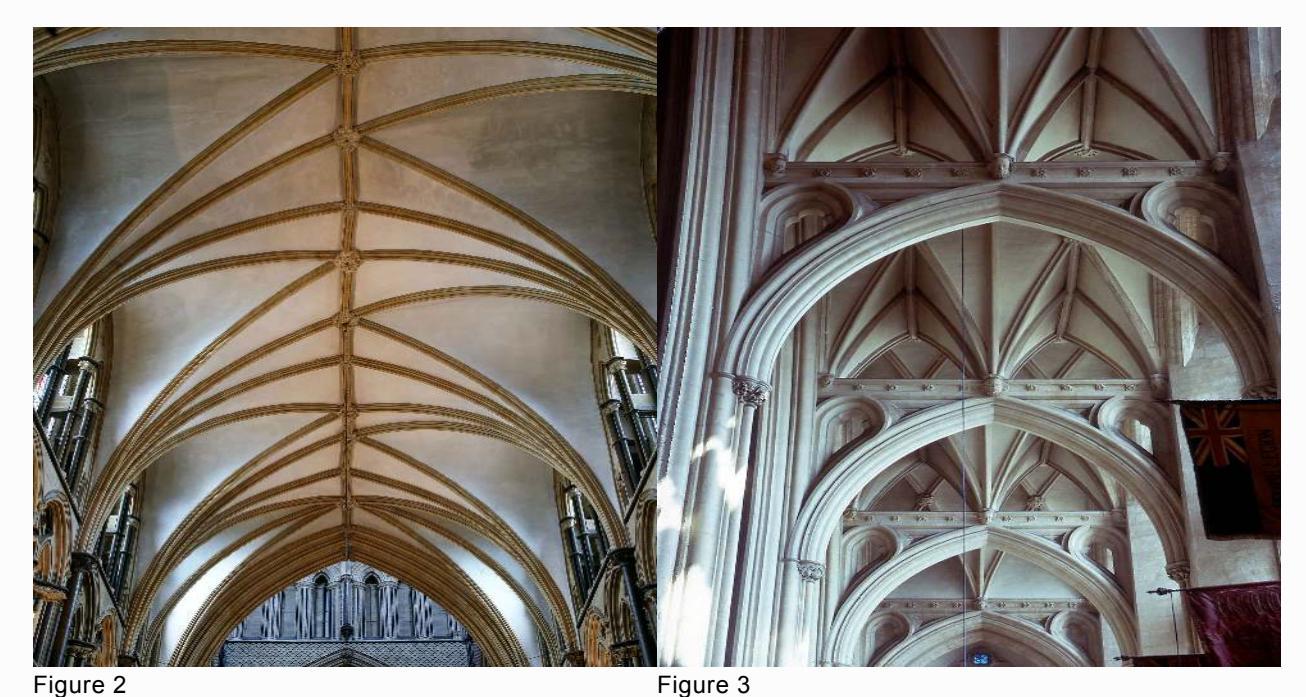
Lincoln Cathedral, vault over St Hugh's choir. Digital image courtesy of Malcolm Thurlby.

The ribbed vault over the early Gothic choir at Lincoln is known for its unorthodox pattern, with additional ribs defying the symmetries associated with contemporary quadripartite or sexpartite vaults (fig. 2).⁸ There were no obvious structural risks attached to this, although there are inconsistencies in the way the vault was buttressed (most notably in the gallery). This is one of many cases where the design appears to have been worked out as building progressed, a "sequential" approach encountered in many an English building.⁹ Although dubbed the "crazy" vault, it can in fact be interpreted as a rational response to the particular geometries of the cathedral, as Peter Kidson showed many years ago.¹⁰

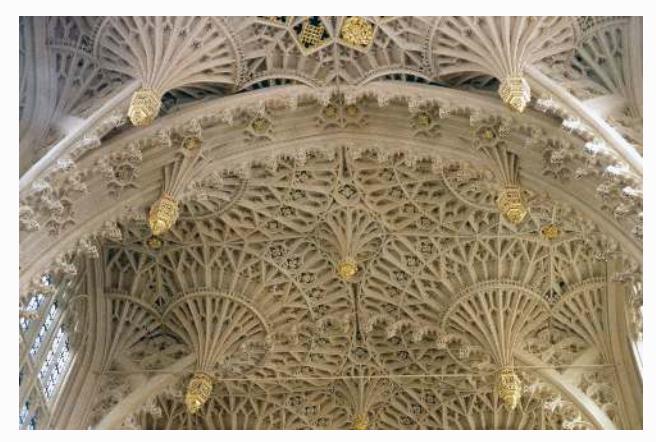
Figure 4

Westminster Abbey, pendant vault over Henry VII's Chapel. Digital image courtesy of Roger Stalley.

Finally, there is the vault of Henry VII's chapel at Westminster, a fantasy world, which, with its stone pendants, seems to defy the laws of gravity (fig. 4).¹² This was a wonderfully adventurous endeavour, though one in which the design was altered during the course of construction: the great transverse arch marking the entry to the sanctuary was apparently inserted as an afterthought. The evidence is visible from the upper surfaces of the vault, but even from below the geometrical forms seem compromised; in the words of Jacques Heyman, the arch "spatchcocked in as an afterthought".¹³

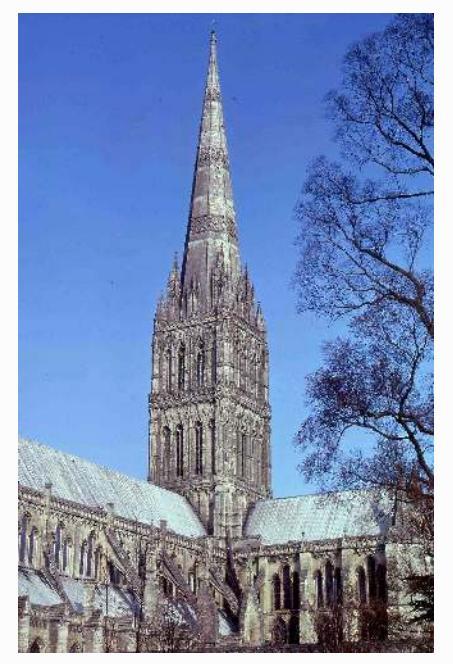
Figure 5

Salisbury Cathedral, tower and spire from the southwest. Digital image courtesy of Roger Stalley.

Tower building was an even more hazardous operation, as demonstrated in recent studies of the tower and spire of Salisbury (fig. 5). This was a stupendously ambitious project, a vast weight of masonry placed over the centre of the church to a height of 123 metres. But as Richard Morris has shown, anxieties developed at an early stage: while the tower was still under construction, the buttressing system was extended and improved, a continuing process that is fundamental to the history of the tower.¹⁵ It is no wonder that Salisbury became the inspiration for William Golding's novel The Spire, with its portrayal of a dean obsessed with mega construction.¹⁶ Fiction this may have been, but it reminds us that inventive architects could not operate without ambitious clients. Major projects involved continuous dialogue between patron and architect, but we rarely get a glimpse of this. Indeed, the degree to which the impetus for invention came from the patron rather than the architect is a perennial issue; it is

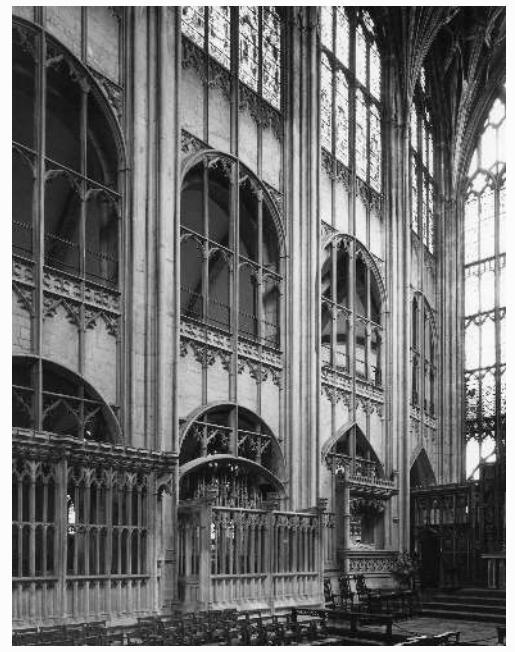
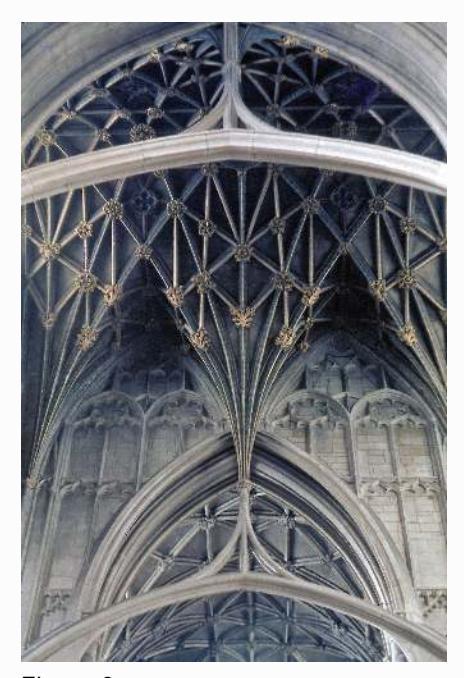
Figure 7

Gloucester Cathedral, vault over the crossing. Collection of Conway Library, Courtauld Institute of Art, London. Digital image courtesy of Courtauld Institute of Art.

Figure 8 Gloucester Cathedral, vault over the crossing. Digital image courtesy of Roger Stalley.

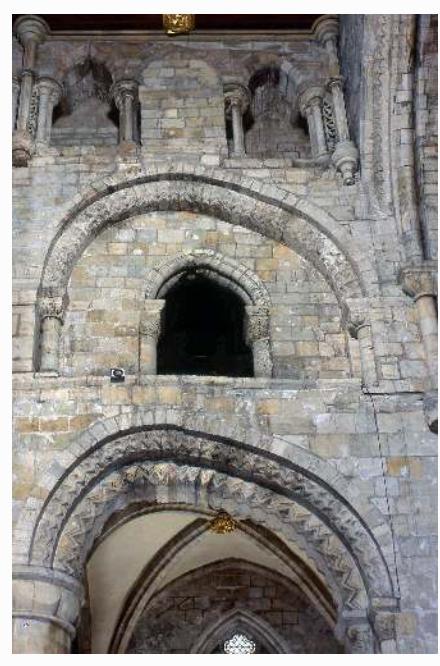
Figure 9

Selby Abbey, first bay of the nave, north side, showing providing a spectacular demonstration of differential settlement. Digital image courtesy of Roger differential settlement, the structural Stalley.

A second factor affecting creativity was the process of incremental or piecemeal construction, whereby building was strung out over a long period, usually as a result of fluctuating resources. This did not necessarily inhibit invention, however, for there were times when master masons seemed to enjoy subverting the designs of their predecessors, sacrificing consistency for varietas. An extreme case of this can be found in the Benedictine church at Selby, a building notorious for its architectural discords.²⁶ The abbey church was begun in the 1120s in a manner characteristic of the time. The builders encountered problems quite soon, having decided to construct a crossing tower at a time when only two bays of the nave had been completed. The weight imposed on the crossing piers caused them to sink below the level of the rest of the building,

differential settlement, the structural phenomenon that English builders found difficult to comprehend (fig. 9). At this point the

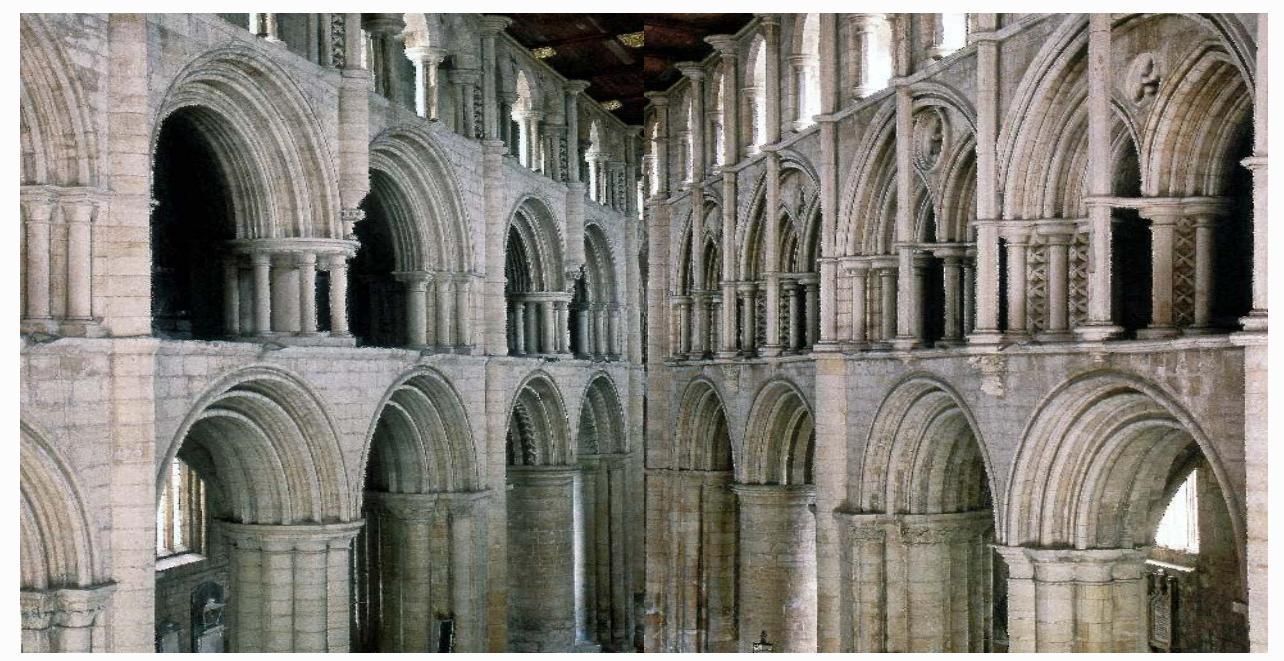
Figure 10 Selby Abbey, interior of the nave, north elevation, looking east. Digital image courtesy of Roger Stalley.

Figure 11 Selby Abbey, interior of the nave, south elevation, looking east. Digital image courtesy of Roger Stalley.

At Selby the north and south elevations were built separately and by the time the south side was designed, a new master had appeared on the scene, one with little respect for the past. Novelty was the order of the day. Inspired by recent work in the transepts at Lincoln, hanging shafts were added to the face of the gallery, colloquially described as "flagpoles" (fig. 11). These shafts might have made sense if a sexpartite vault had been planned, but this could never have been the intention at Selby.²⁸ There is a wonderful sense of bravado about the architecture of the nave, a triumph for ingenuity over consistency. Many churches have arcades that differ north and south, but rarely are the contrasts quite so stark as at Selby. The curiosities here clearly owed much to human choice, but whether on the part of the abbots, the community, or a series of unusually persuasive master masons remains a matter of conjecture. On the other hand, Selby may provide clues about how buildings were seen and appreciated. It seems that pleasure and delight came from individual parts, not necessarily from the totality of the building. This is not altogether surprising given the way great churches were experienced on a daily basis. While impressions gained by modern visitors tend to be conditioned by vistas along the main axes, monastic communities moved around their buildings and were familiar with lateral and partial views. It is clear that splendour and variety were values much admired at the time, as suggested by the use of such epithets as sumptuosus, varietas, venustus, incomparabilis, elegantia, splendidus, pretiosus.²⁹ Colour, line, and pattern, along with demonstrations of ingenuity, evidently drew a greater aesthetic response than classical notions of harmony or integrity.³⁰ As Larry Hoey maintained, we are dealing with "a mentality that saw virtue in experiment and put little stock in uniformity and symmetry".³¹ The delight in variation was not universal, and it is important to remember that there are plenty of English monuments where the initial design was steadfastly maintained throughout the course of construction.³²

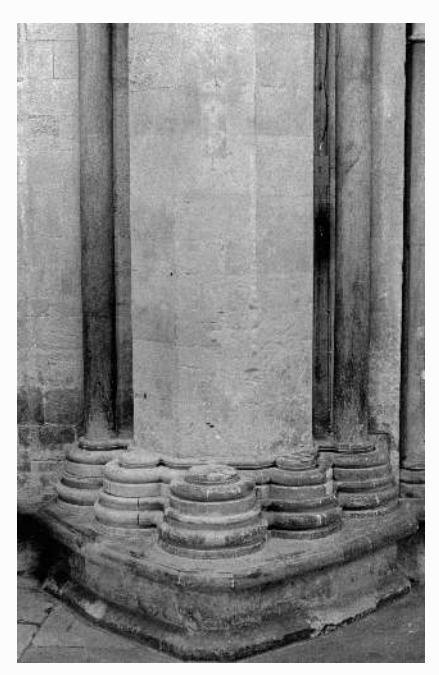
Figure 13

St Albans Cathedral, interior of the nave, west wall, engaged pier designed for detached shafts. Digital image courtesy of Roger Stalley.

What makes this episode especially interesting is that the crisis is fossilized in the fabric of the building. Hugh de Goldclif's nave extension was planned with sumptuous piers, formed of octagons surrounded with eight detached shafts; against the west wall one can still see sections of a respond designed in this way, ready to receive shafts which were never inserted (fig. 13). The internal faces of the porches were likewise ambitious, with double arcades, contrasting arch forms, and luxurious capitals. The nave extension was eventually completed, but to a far more austere design. It was a dull arrangement with no high vaults, minimal detached shafting, and the use of moulded rather than foliate capitals. By now the creative ambitions of Hugh de Goldclif and abbot John had been consigned to the past.³⁷ Here is a case where an excess of invention contributed to a breakdown in trust between architect and patron.

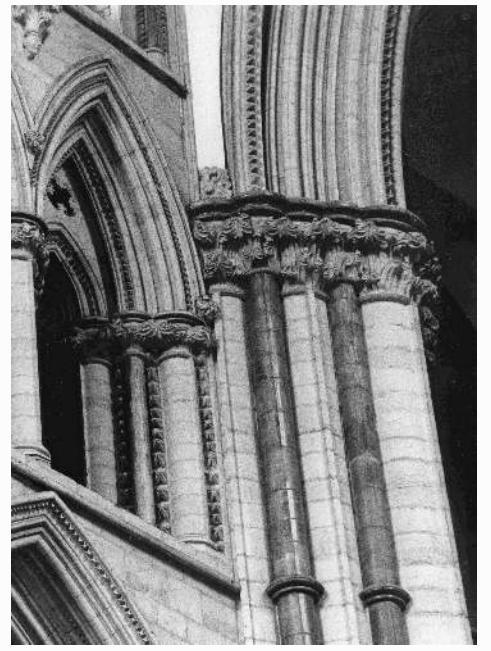
Figure 15 Lincoln Cathedral, north-east crossing pier. Digital image courtesy of Roger Stalley.

The Annals of Dunstable priory provide an additional clue to the cause of the trouble at Lincoln. Following the collapse, we are told that "the columns and arches were reinforced on every side" (*donec circumquaque columnae et arcus firmarentur*),⁴⁸ and it is these reinforced piers that are visible in the cathedral today (fig. 15). The Annals clearly imply that the cause of the disaster was the feeble construction of the original crossing piers, erected some forty years earlier. These had formed part of St Hugh's choir, the work of one of the most inventive of all English medieval architects.⁴⁹ His surviving piers are ornamented with detached shafts, as was presumably the case with the original eastern crossing piers. Responsibility for the crash should thus be directed, at least in part, towards the architect of the choir, the author of the "crazy" vaults, the ingenious syncopated arcading, and the so-called "Trondheim" pier, an individual celebrated for his creativity.⁵⁰ Invention, it seems, came at a price. But equally culpable was his successor, who chose to erect a tower over inadequate supports, a common failing in English building. When it

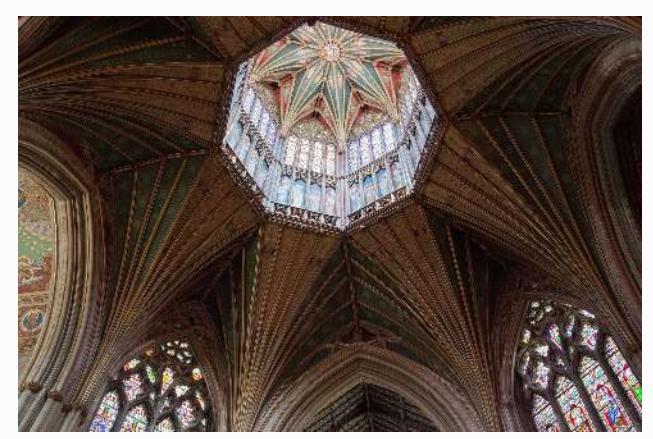
Figure 16

Ely Cathedral, interior of the octagon. Digital image courtesy of Alamy Stock Photo / Photo: Louis Champion.

While it is easy to admire the visual effects of the Ely octagon, it is important to remember that invention lay as much in its construction as in the design itself. It is also worth noting that the lantern was an ingenious way of reducing the need for excessive lengths of timber, one reason perhaps why it became an essential element in the scheme. In fact some of the more subtle features of the octagon were products of what was a complex design process: for example, the geometry by which an irregular octagon at ground level culminates in a lantern of regular octagonal shape; or the way the lantern itself is turned so that its angles, not its straight sides, lie on the main axes, a consequence of the disposition of the supporting ribs.⁶⁵

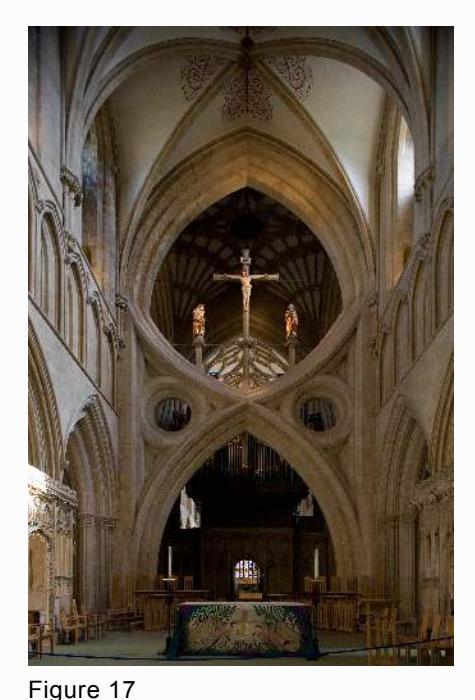
Wells Cathedral, 'scissor arches' within the crossing. Digital image courtesy of Globus Images / Alamy Stock Photo.

The problem they were intended to solve is a familiar one: the construction of heavy crossing towers built without sufficient attention to the stresses imposed on the fabric below. There have been suggestions that the strainer arches at Wells were not much use, taking less than 10 percent of the load of the tower, and, as they were not copied, there may have been doubts about their value at the time.⁶⁸ One would imagine that the clergy were reluctant to accept such an intrusive solution, but the prospect of disaster no doubt helped to focus the mind. It is not so much the originality of the strainer arches that is impressive but the sheer confidence and bravado of the design. Even though the arches have become part of the very identity of the cathedral, one wonders whether the fourteenth-century canons regarded them as anything more than a painful necessity. Whatever the intensity of opinion, the boldness of the solution suggests a remarkable
